# District Wide Facilities Plan Erie's Public Schools

Copyright © November 7, 2018

HHSDR Architects / Engineers  
#4220

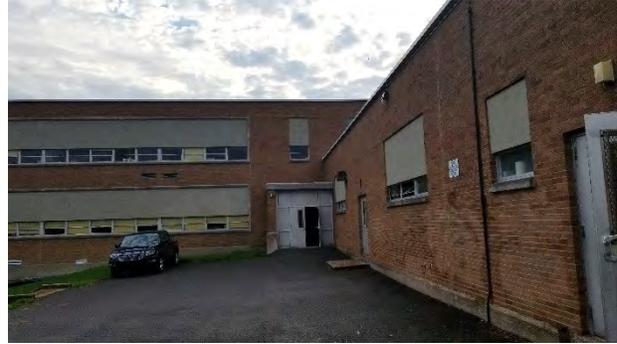
**Windows:** The existing windows are single pane and not thermally broken. Caulking has also failed. These should be replaced throughout to install new windows with dual pane glazing and thermally broken frames.

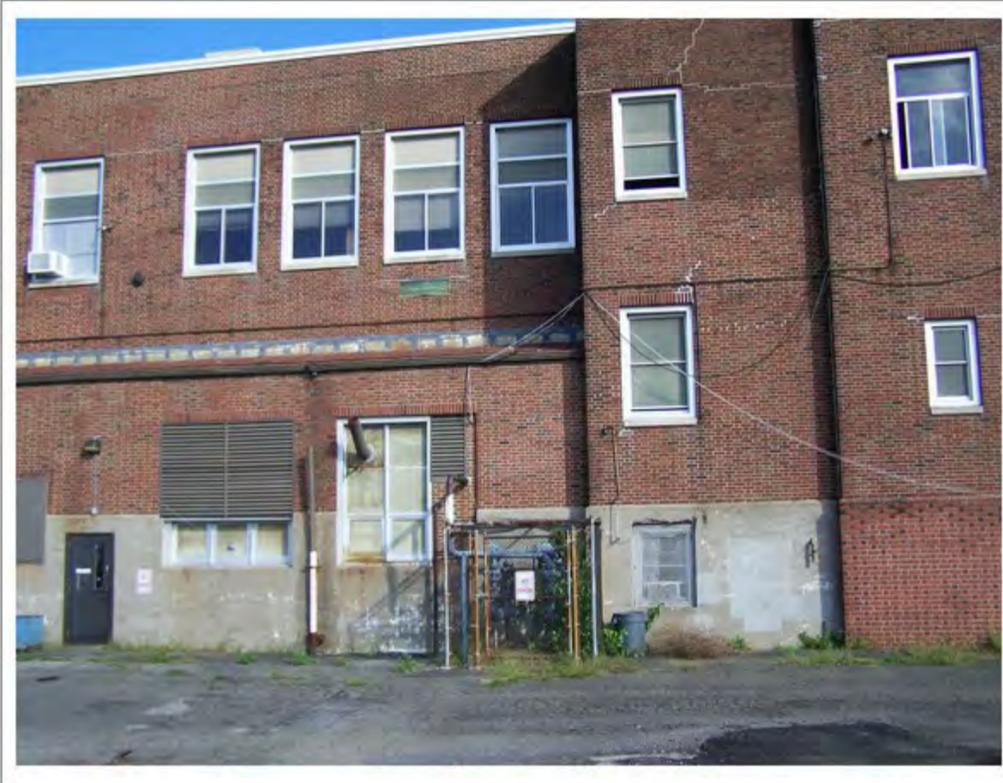
Edison 100\_2893 Brick cracking

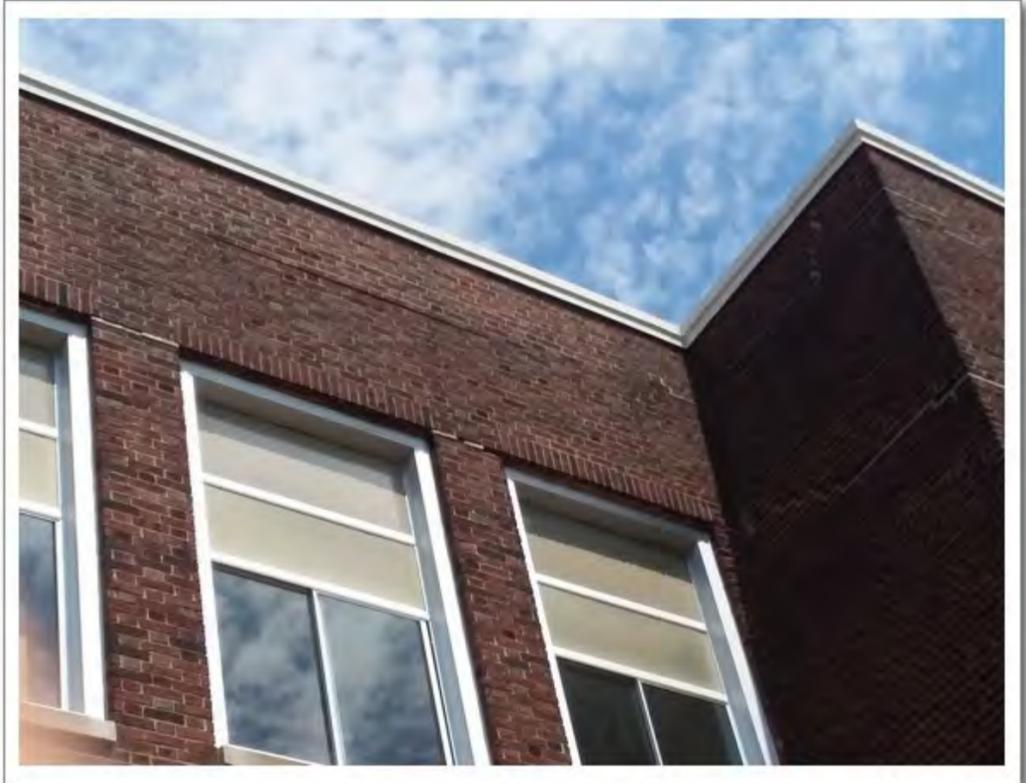
Edison 100\_2905 Brick cracking

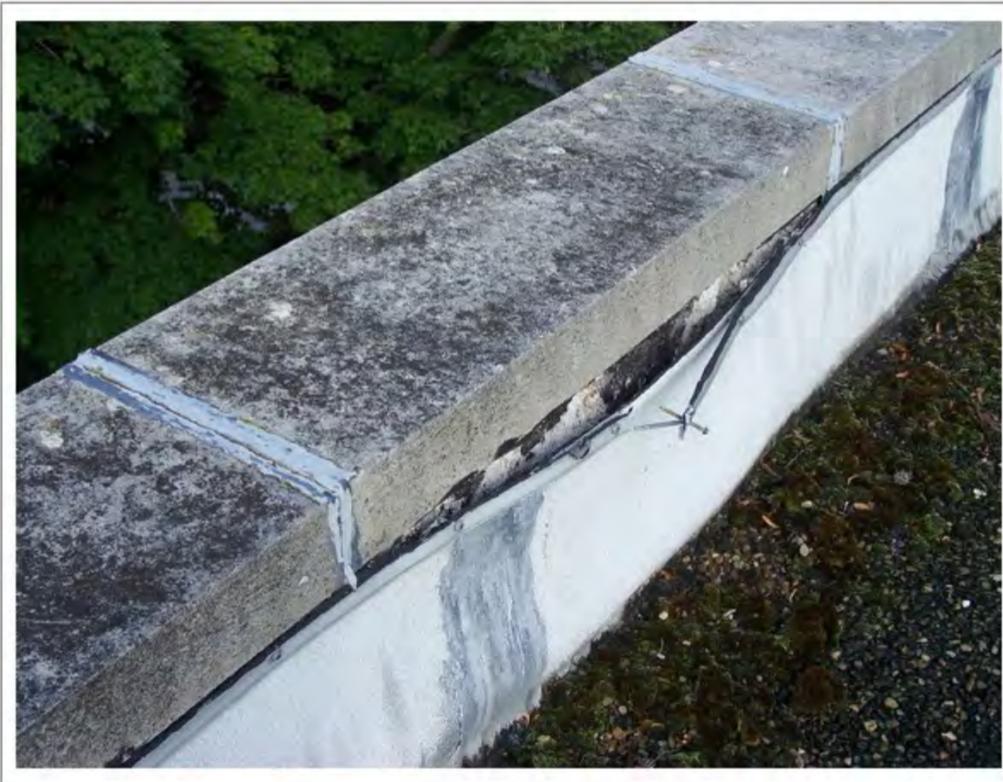
Edison 101\_7208 Stone Coping

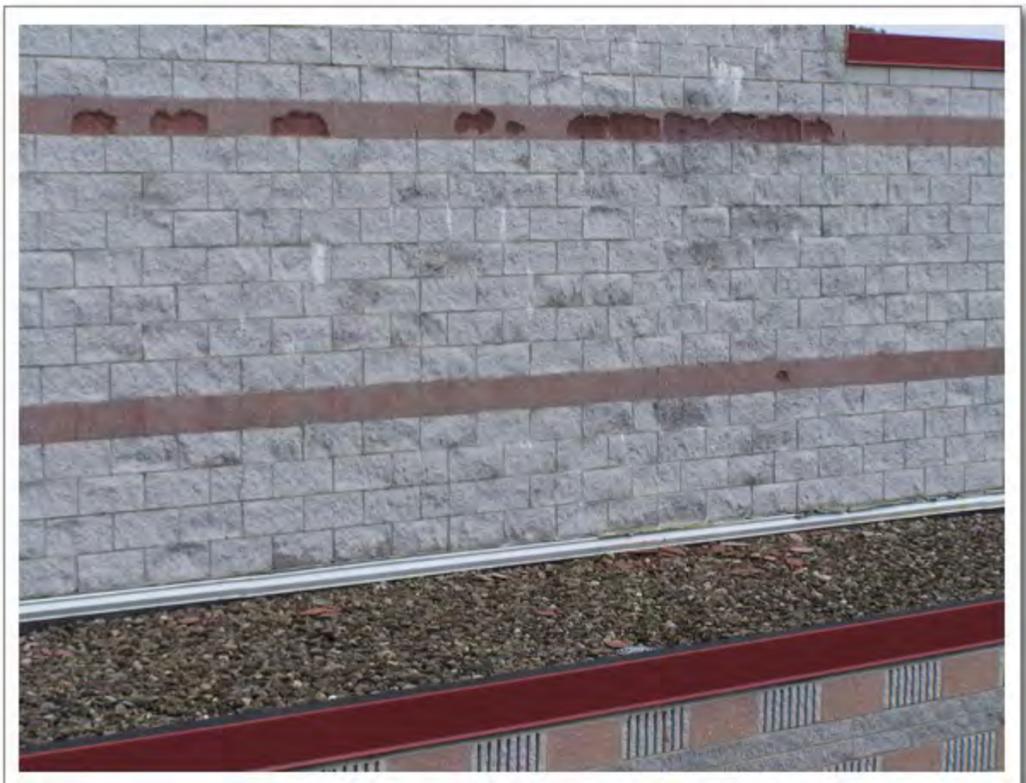
EMS 100\_2798 Spalling Block above Dock Roof

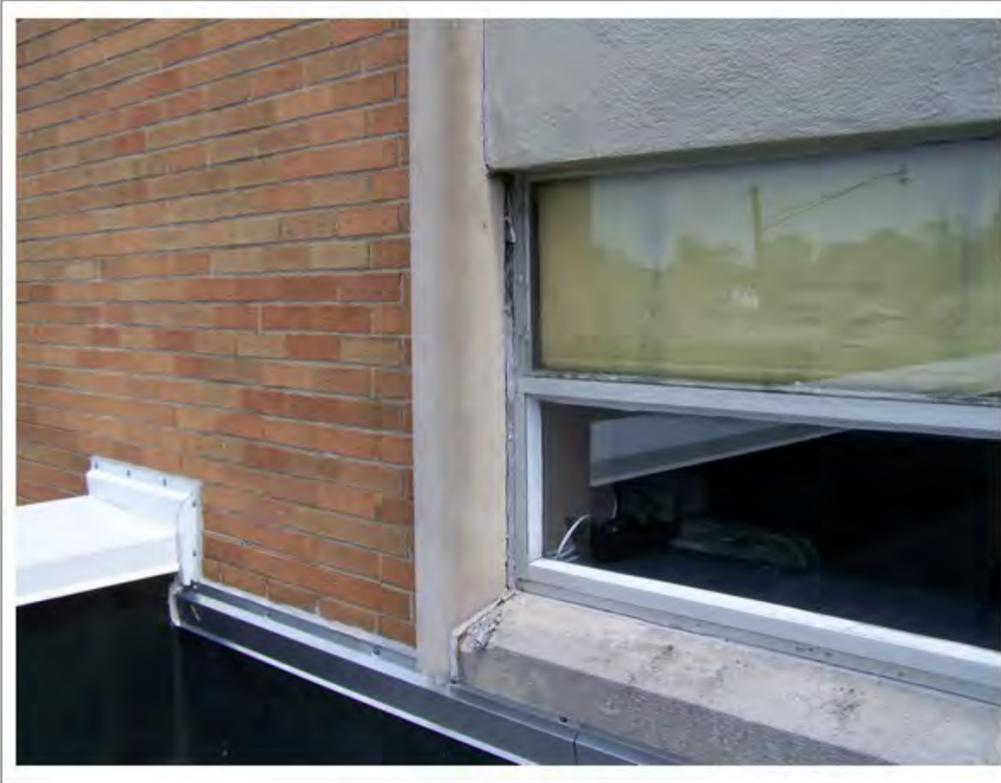
Grover Cleveland 100\_2203 Window Caulking

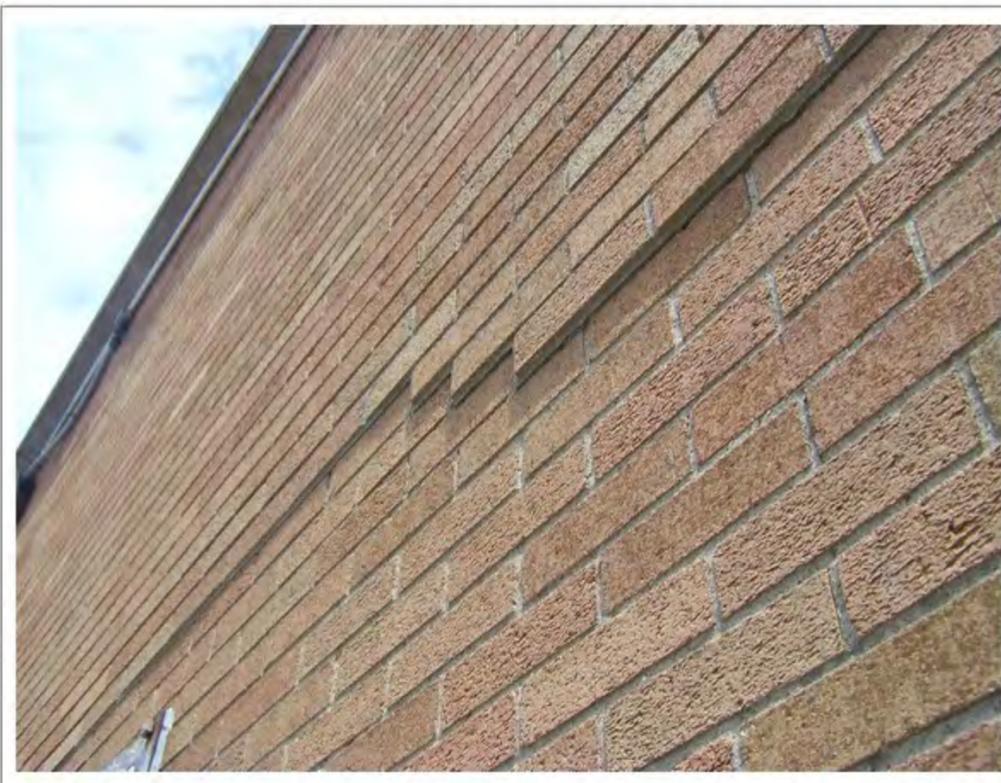
Grover Cleveland 101\_6832 Brick cracking

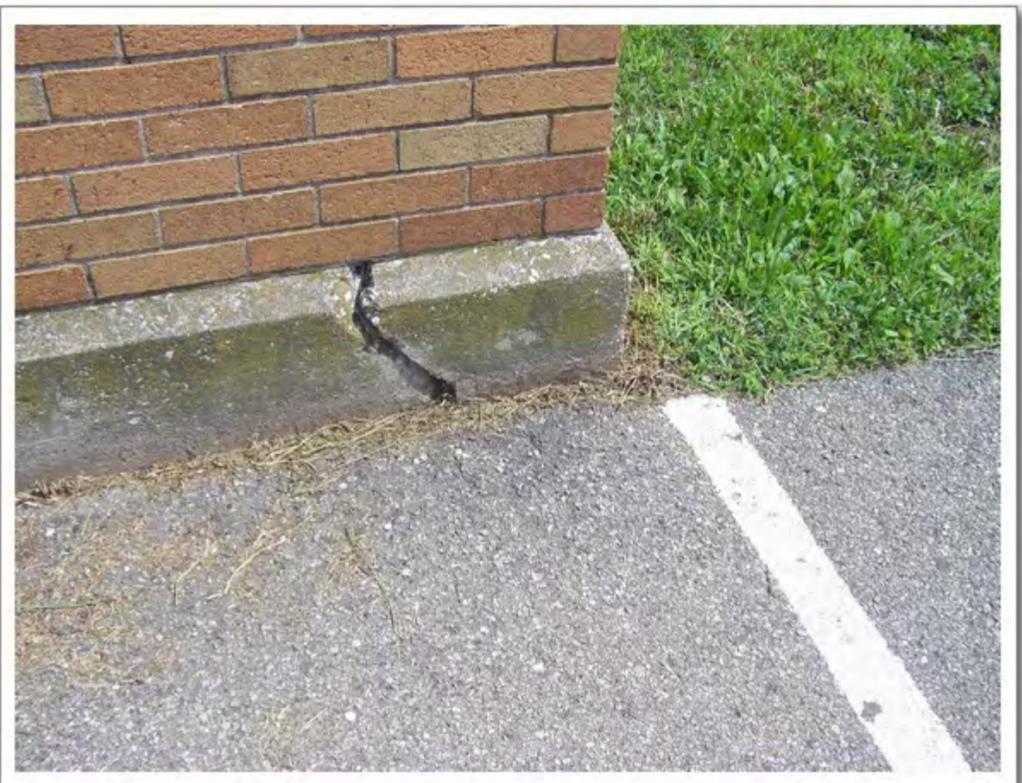
Grover Cleveland 101\_6833 Brick cracking

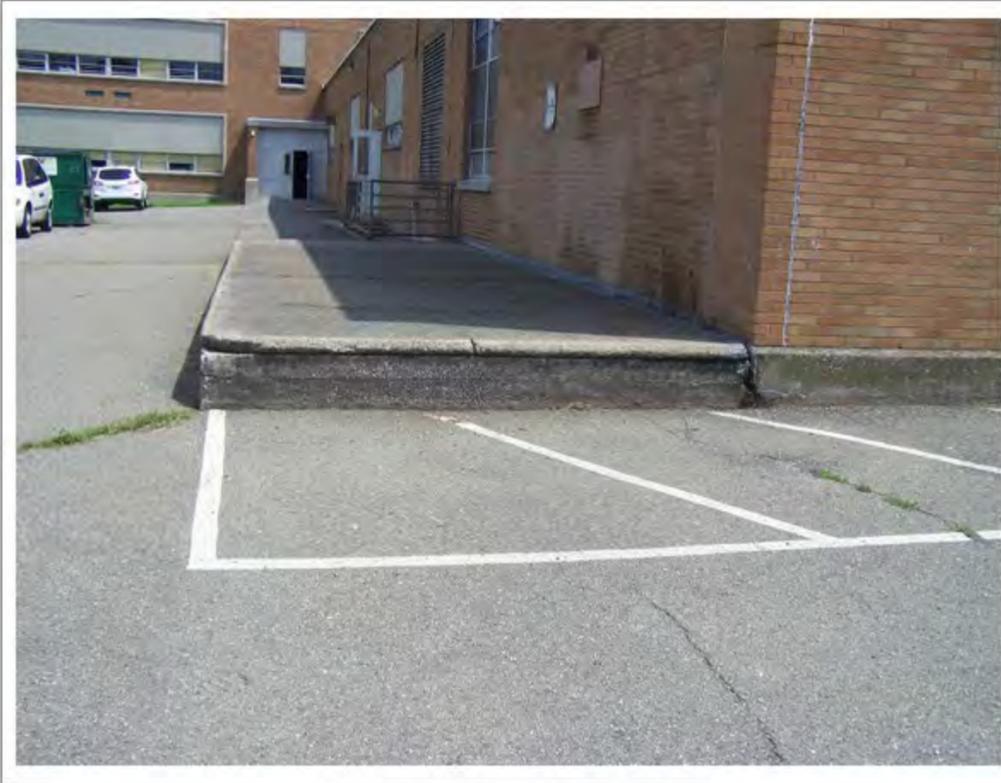
Grover Cleveland 101\_6834 Slab

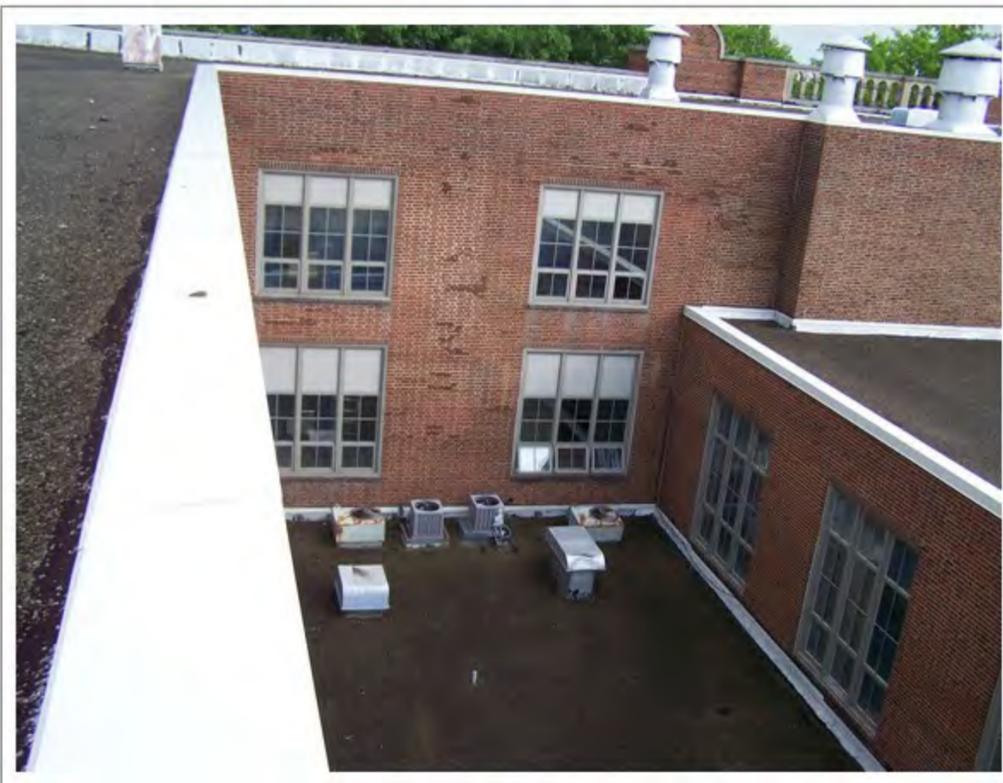
Lincoln 100\_2133 Brick spalling

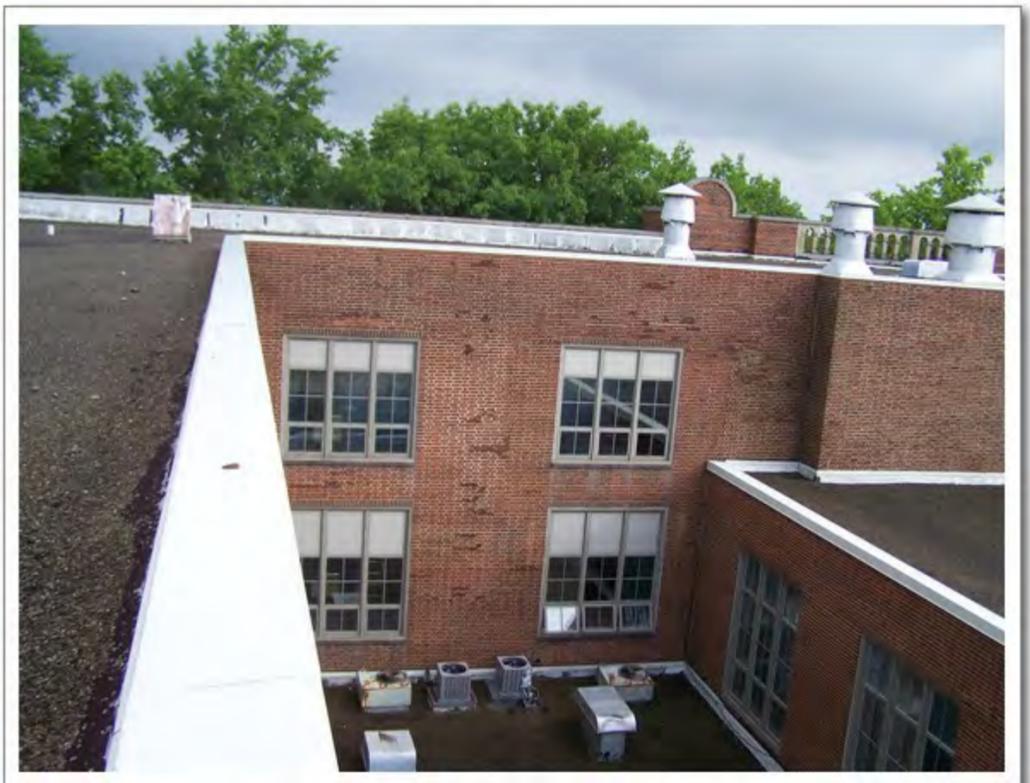
Lincoln 100\_2134 Brick Spalling

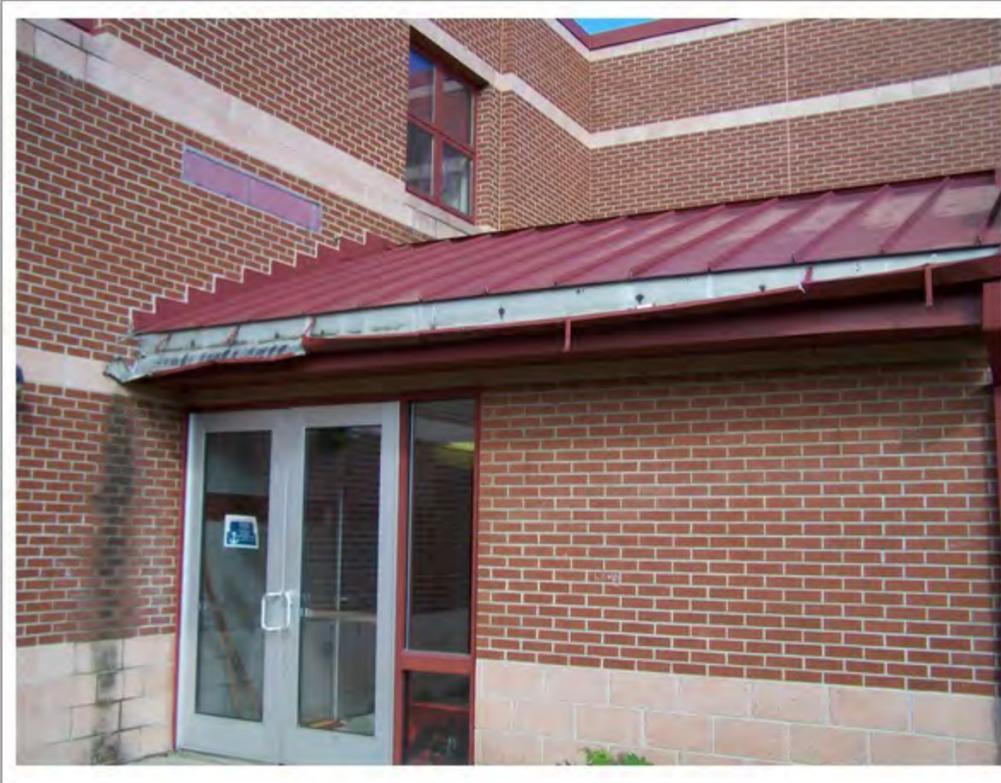
McKinley 100\_2905 Damaged Gutter

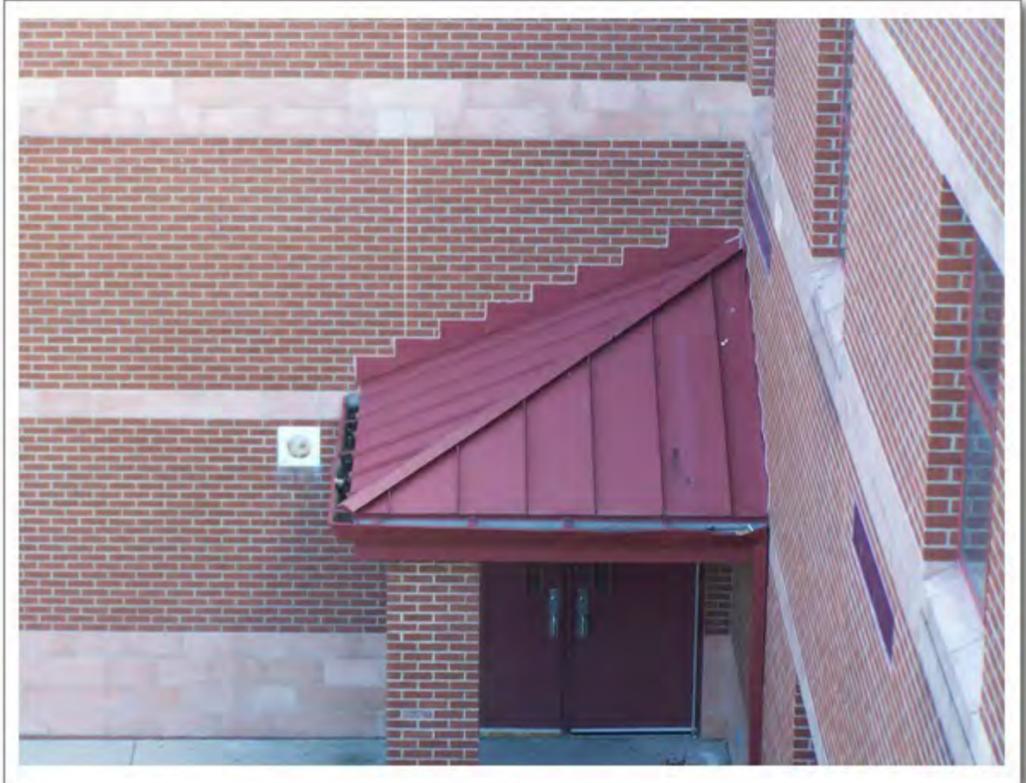
McKinley 100\_2921 Damaged Gutter

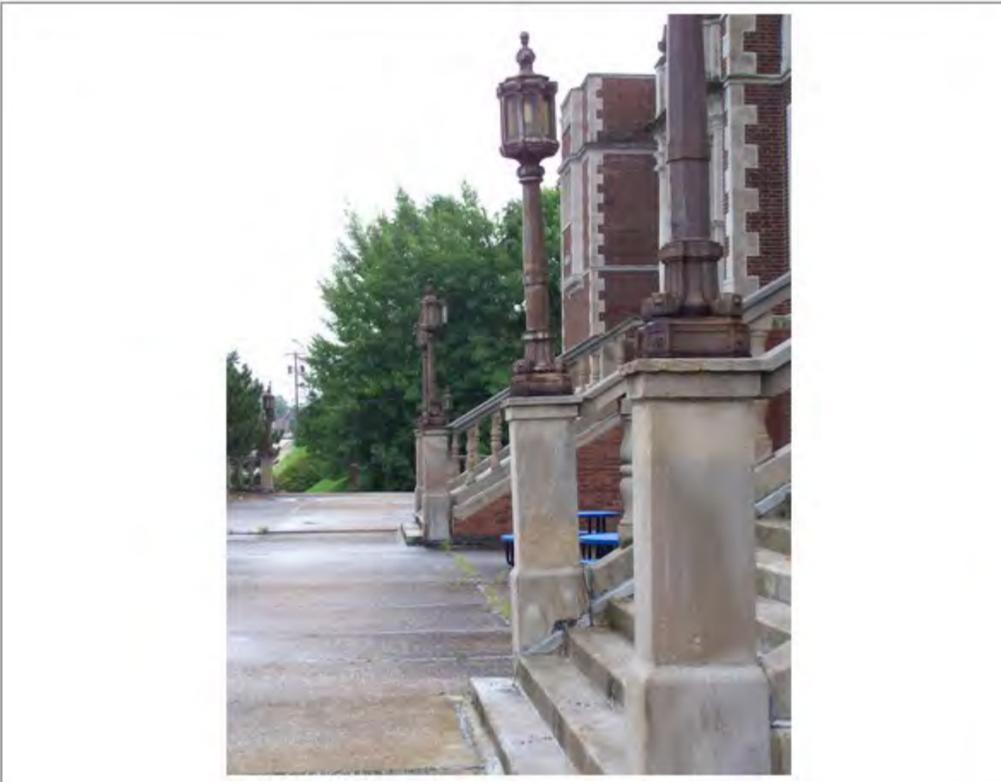
NWPACA 100\_2737 Exterior light post

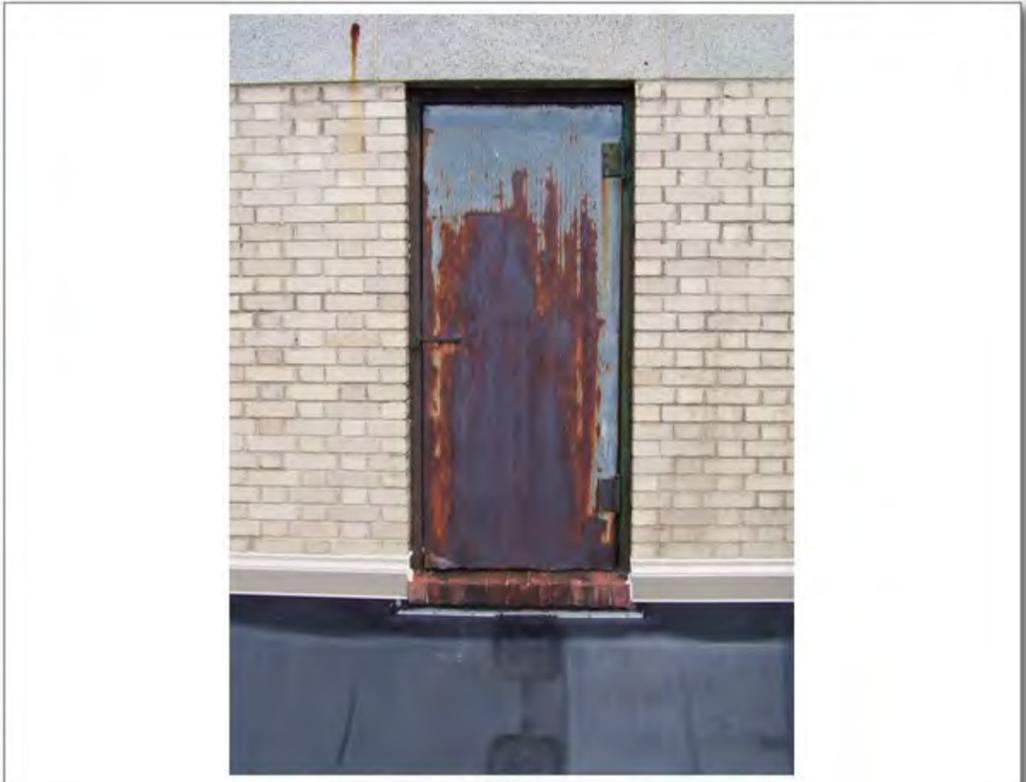
SVMS 100\_2431 Rusted Roof Door

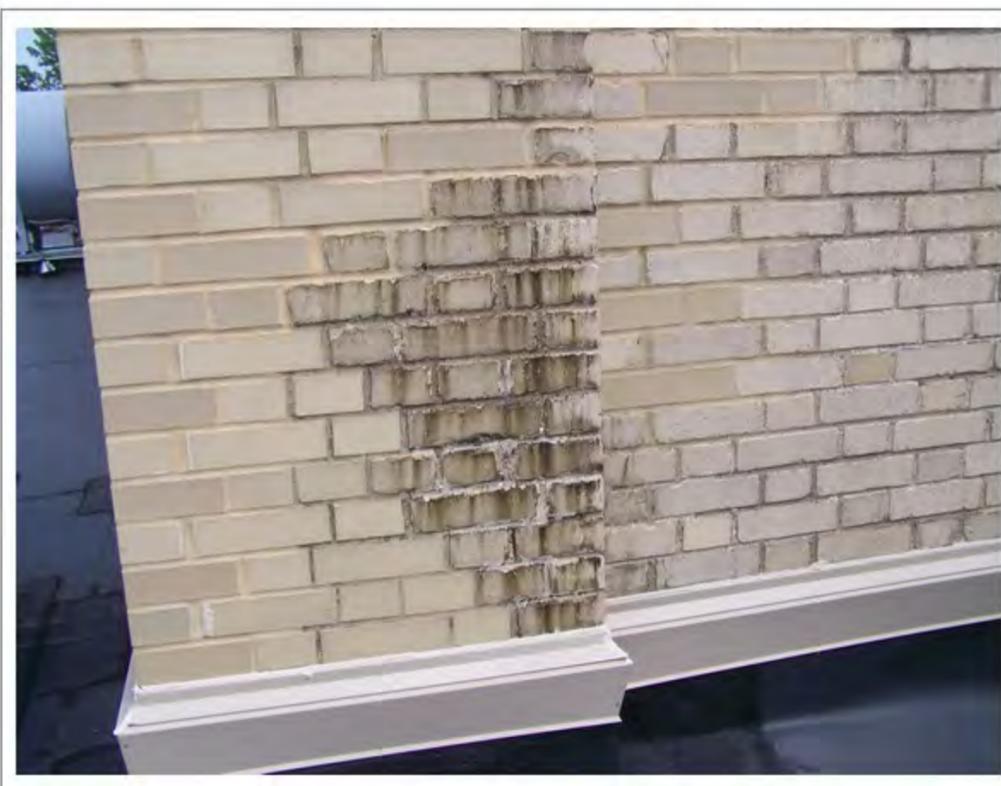
SVMS 100\_2432 Brick joints on Roof
