# District Wide Facilities Plan Erie's Public Schools

Copyright © November 7, 2018

HHSDR Architects / Engineers  
#4220

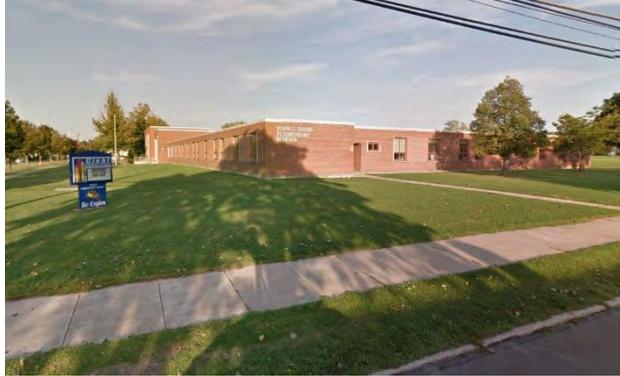
**Roof:** The roof is an adhered Versico .060 mil reinforced EPDM (rubber) roof system over a concrete roof deck. Approximately 60,407 s.f. was installed approximately 2001, and the system should have a 20-year warranty. The installing contractor did not file the warranty paperwork. HHS DR is working with Versico to inspect and repair the roof, and to reinstate the original warranty for the remaining period.

Insulation is buckling under the EPDM in some locations, and leaks are evident along the gymnasium corridor wall at wall flashing seams.

**Windows:** Existing windows have thermally broken frames and are double glazed. Overall the windows and hardware appear to be in good condition.

- Periodic maintenance should occur until the roof system can be scheduled for replacement.

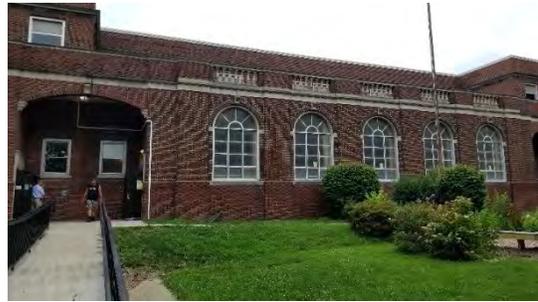
The high (gym) roof is an adhered Versico .060 mil EPDM (rubber) roof system of approximately 12,885 s.f., installed over structural concrete deck, installed on January 26, 2015.

The warranty expires on January 25, 2035. One newer roof ladder was installed to the high roof. Other low roof areas have no ladder access. All membrane appears to be in good condition with positive slope to the roof drains. Metal coping was installed on this roof area.

The low roof areas are an older built-up roof system with gravel ballast. They total approximately 15,885 s.f. All areas appear to have a high degree of ponding water. Other issues noted include an old roof hatch which should be replaced, and roof hatch ladder which should be extended. Termination bars are coming loose under the stone coping, allowing water infiltration.

A small low roof on the south side of the building is a corroded metal roof with two (2) downspouts, one of which is unattached.

- Replace low roof areas, including the metal roof.
- Repair/replace brick/masonry wall areas which are cracking.
- Repair the stone coping.

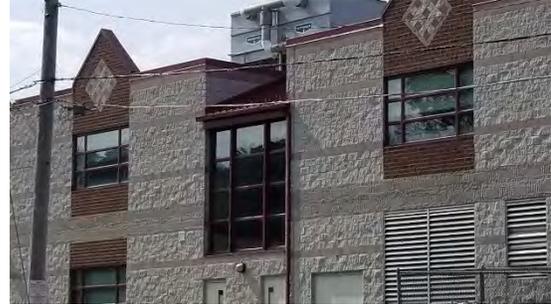
The roof is a ballasted .045 EPDM (rubber) membrane roof system installed over steel roof deck. Approximately 101,500 s.f. was installed during the building's construction in 1997. The School Engineer noted occasional leaks caused by wind-driven rain. The source for the leak behind the entrance has not yet been found. Also noted were membrane flashings pulling away from the wall.

This roof is well beyond its life expectancy, but can be maintained until replacement can be scheduled. The split-face concrete block above the loading dock roof was observed to be spalling.

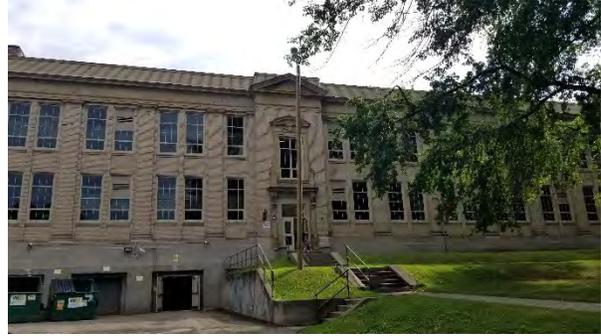
The arch top of windows at the sides of the Auditorium are leaking. It appears that caulking at the jambs has failed. This condition is damaging the wood casings on the inside of the space.

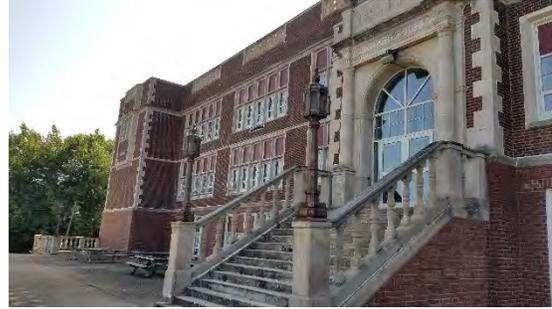
**(continued):** In the boiler room, several damaged concrete beams require repairs.

At the promenade, significant structural problems exist at the concrete surface, stairs, and building spaces beneath. Both existing north stairs existing onto the promenade are presently shored in place due to significant deterioration of the structure below.

- For the promenade, a discussion of the programming of the spaces below should ensue prior to developing a scope of work for repairs. The District should also consider the extent to which it desires to retain the historic character of the school.

- Remove portions or all of the promenade slab where significant structural damage below is present. Remove north stairs exiting onto promenade. Install new stair structures. Pour new concrete stairs. Repair and reset stone rails, ornamental lights and brick sidewalls.

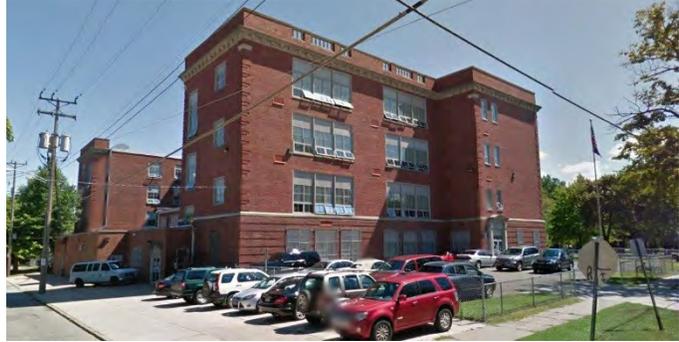
In general, the school is very well maintained. Finishes are in good condition overall, but areas of carpeting and VCT require replacement. Areas of ceiling tile also require replacement from past leak damage.

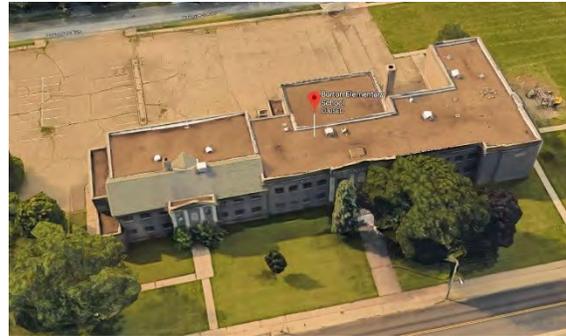
**Windows:** Overall the windows are in good to fair condition. They are dual pane with wood frames on the interior. Select units could be re-glazed at locations of condensation.

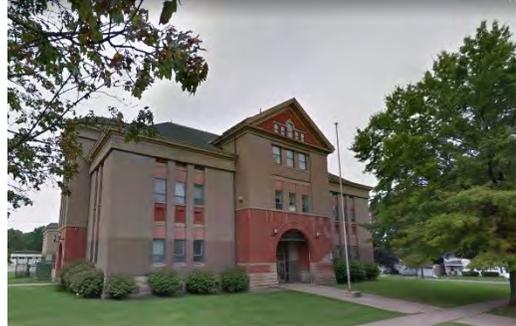
**Site:** The school comprises more than half of the entire city block bounded by Plum Street, West 24th Street, Cascade Street and West 23rd Street. The site contains parking for approximately 35 vehicles; a separately paved area used for staging and deliveries; two modular classroom structures; a baseball field; and lawn areas. Overall the site is in fair condition. The existing paving will need to be repaired, seal coated and re-stripped. Existing walks are in fair condition.

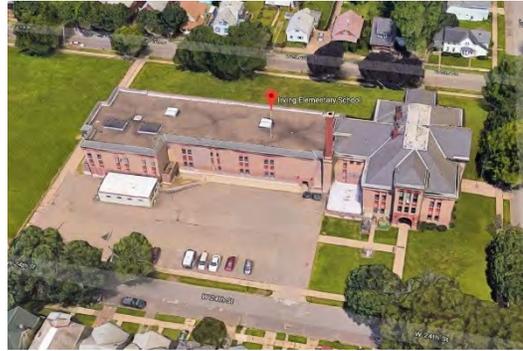
**Windows:** Overall the windows are in fair to poor condition. Units that are single pane with aluminum frames should be replaced with new dual pane, thermally broken units. At select locations existing windows have been replaced in previous renovations and appear to be dual pane, thermally broken units. At select locations existing dual pane wood frame windows should be replaced due to damage and water infiltration.

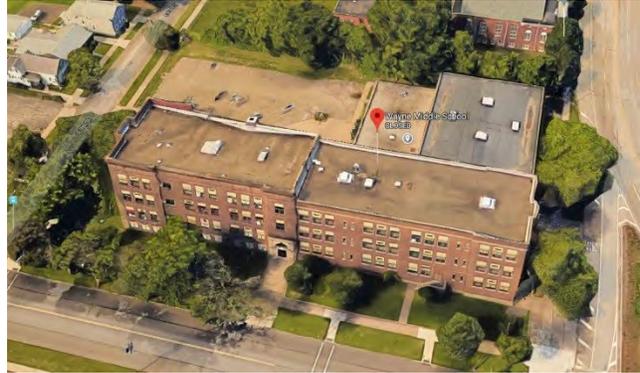
The approximately 8-foot high parapet wall at the southwest corner is bowing in, and appears to be causing inside face brick wall to be spalling. No emergency repairs are needed on the roof at this time.

**Windows:** Overall the windows are in fair to poor condition. Units that are single pane with aluminum frames should be replaced with new dual pane, thermally broken units. At select locations existing windows have been replaced in previous renovations and appear to be dual pane, thermally broken units.

- Replace existing rainwater conductors which are clogged with roof tar.

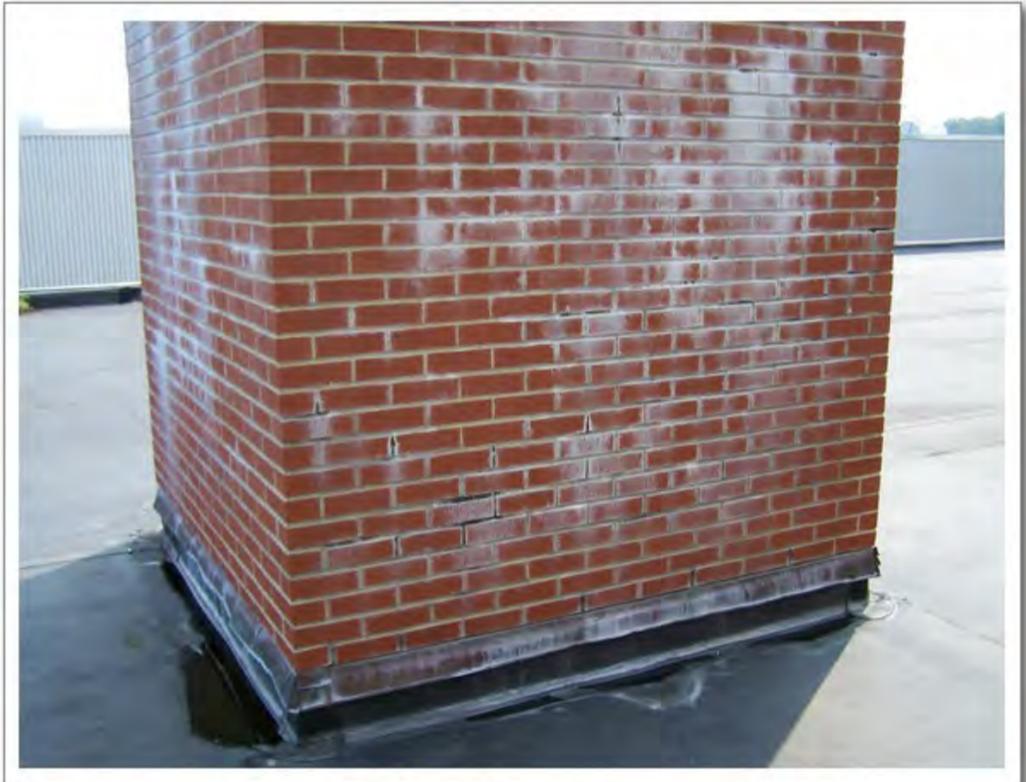
EHS 100\_2270 Stack Efflorescence

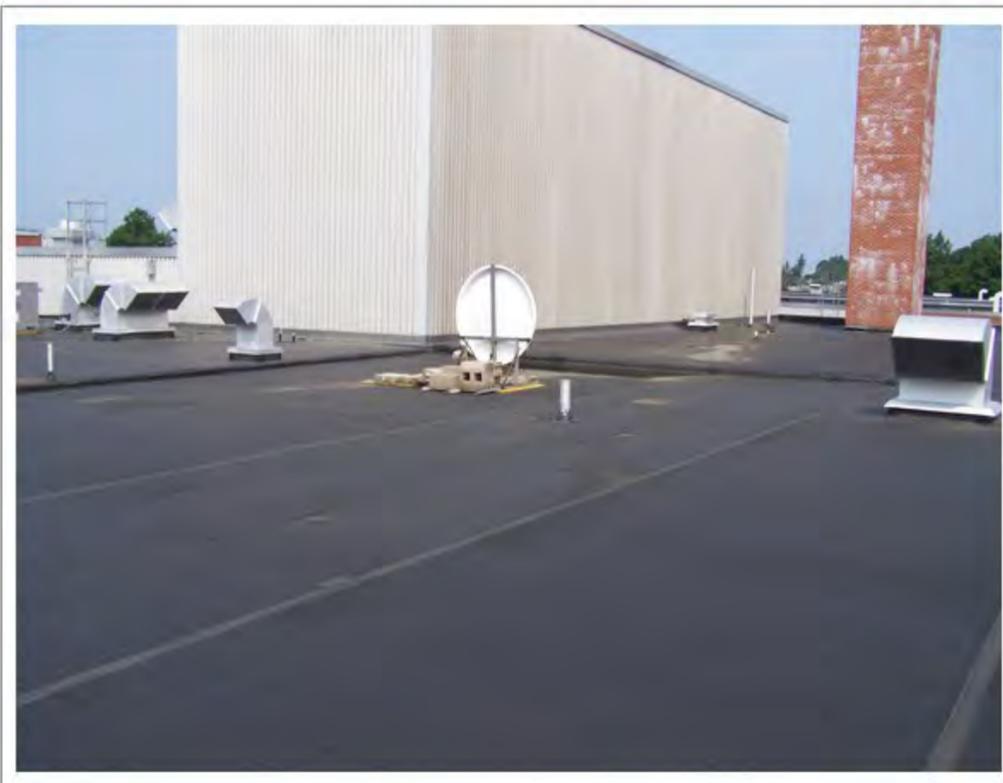
EHS 100\_2274 Stack Efflorescence

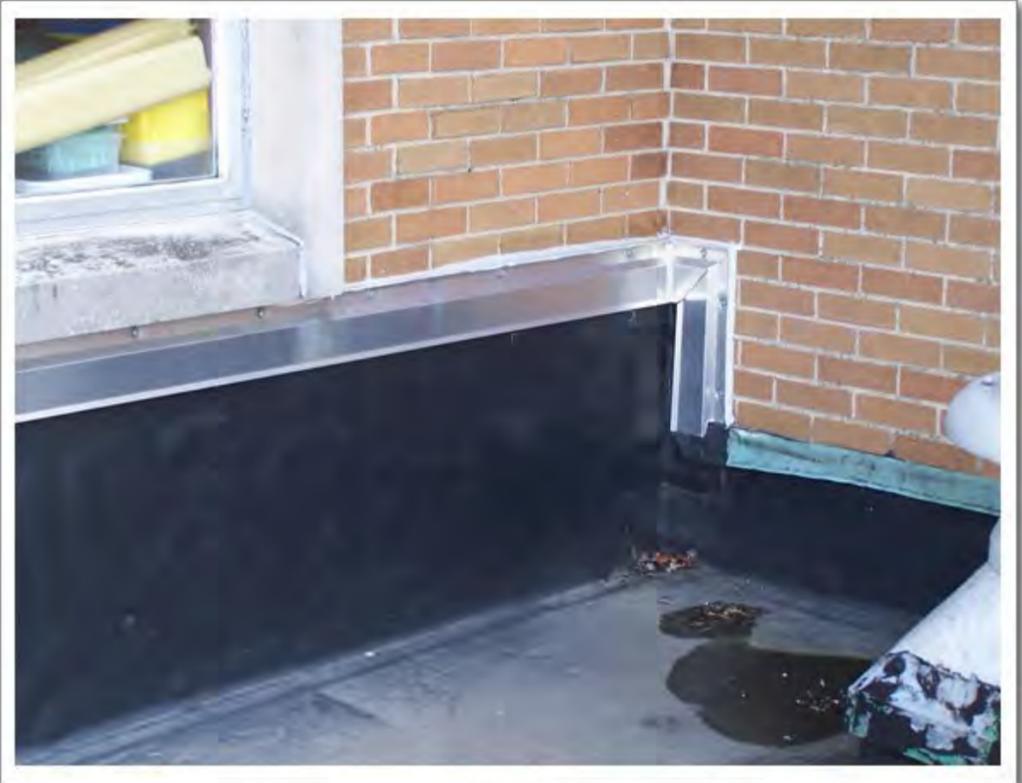
Grover Cleveland 100\_2206 Window caulking

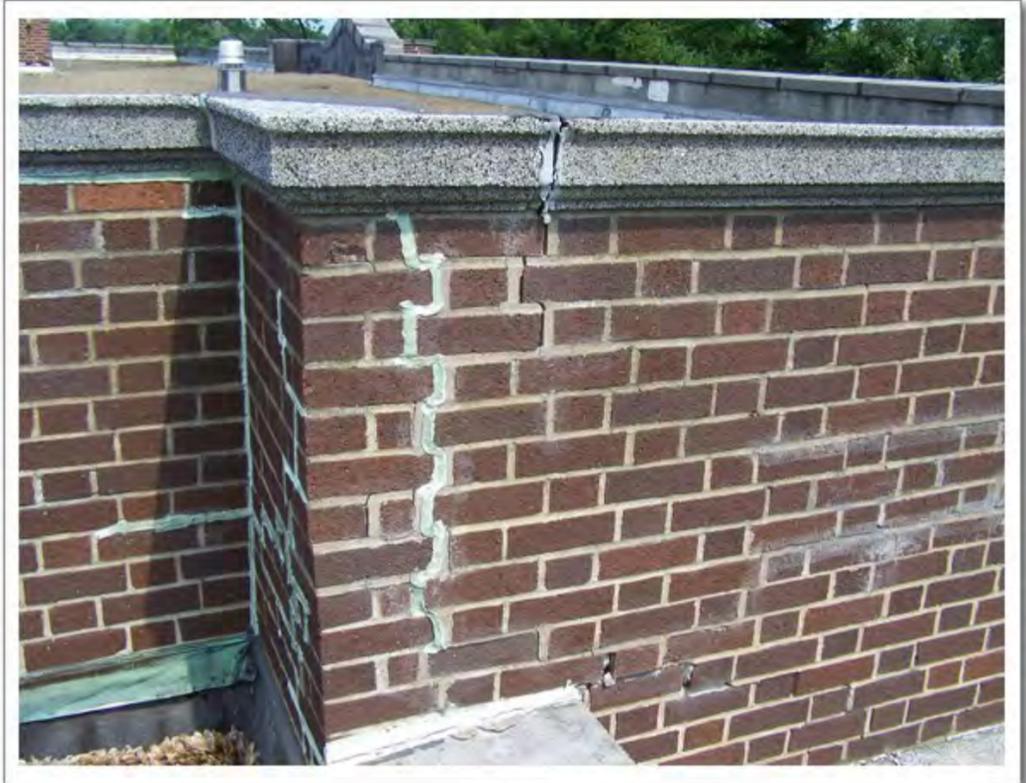
Harding 100\_2321 Parapet wall brick

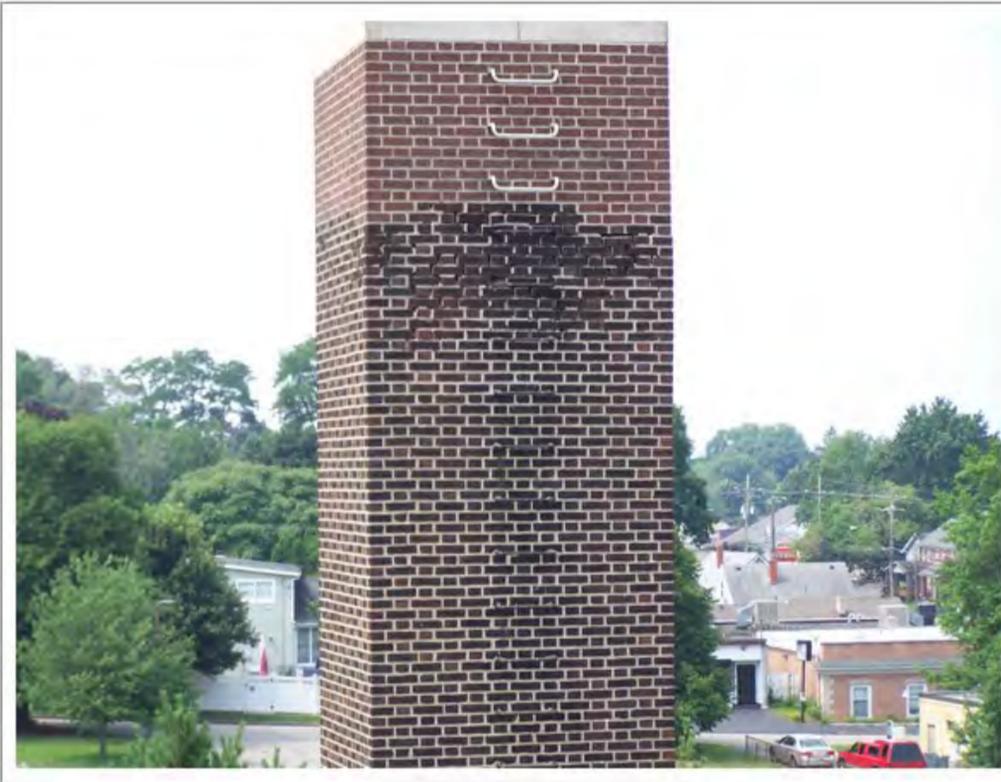
Harding 100\_2333 Stack brick mortar

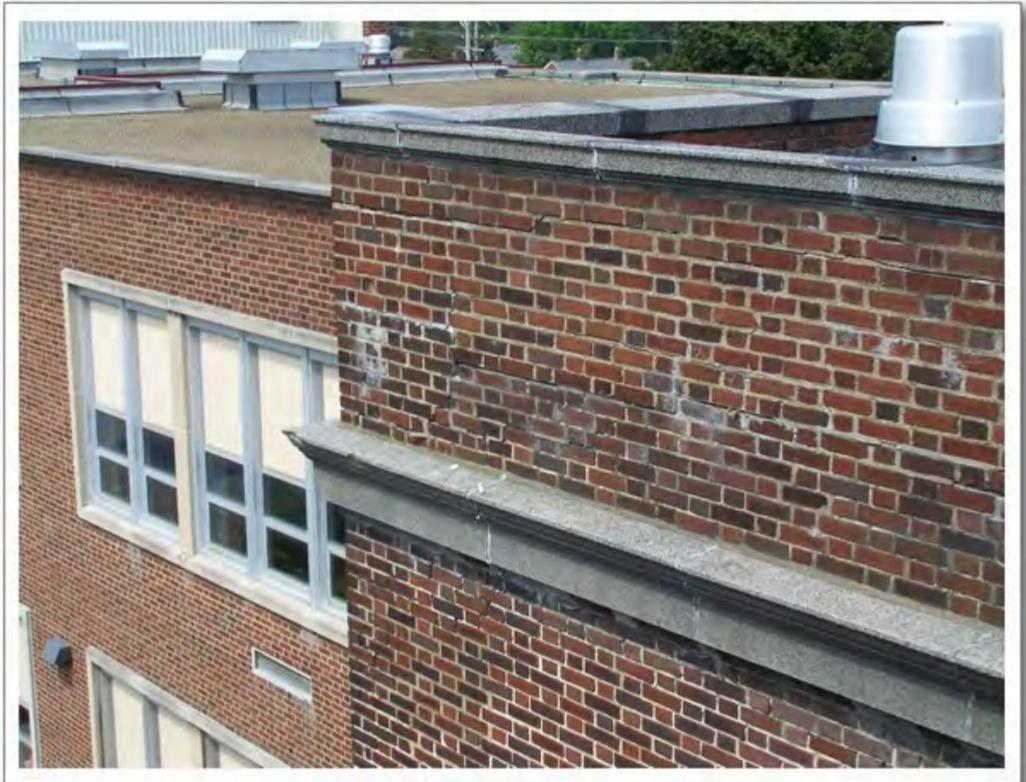
Harding 100\_2340 Parapet wall brick

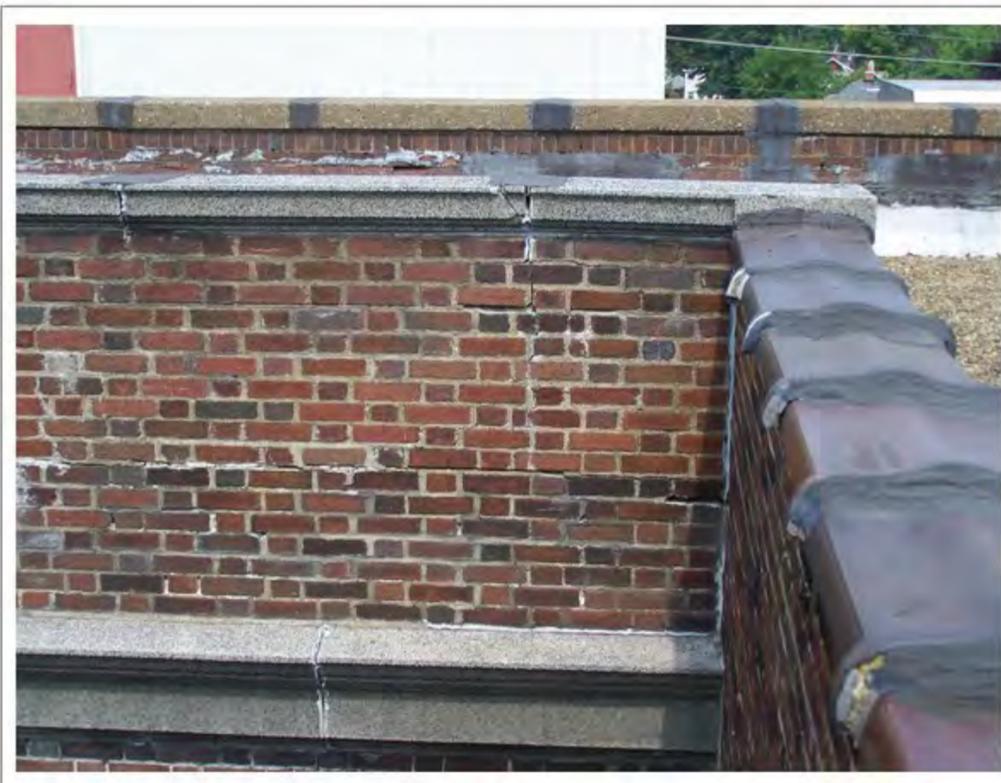
Harding 100\_2341 Parapet wall brick

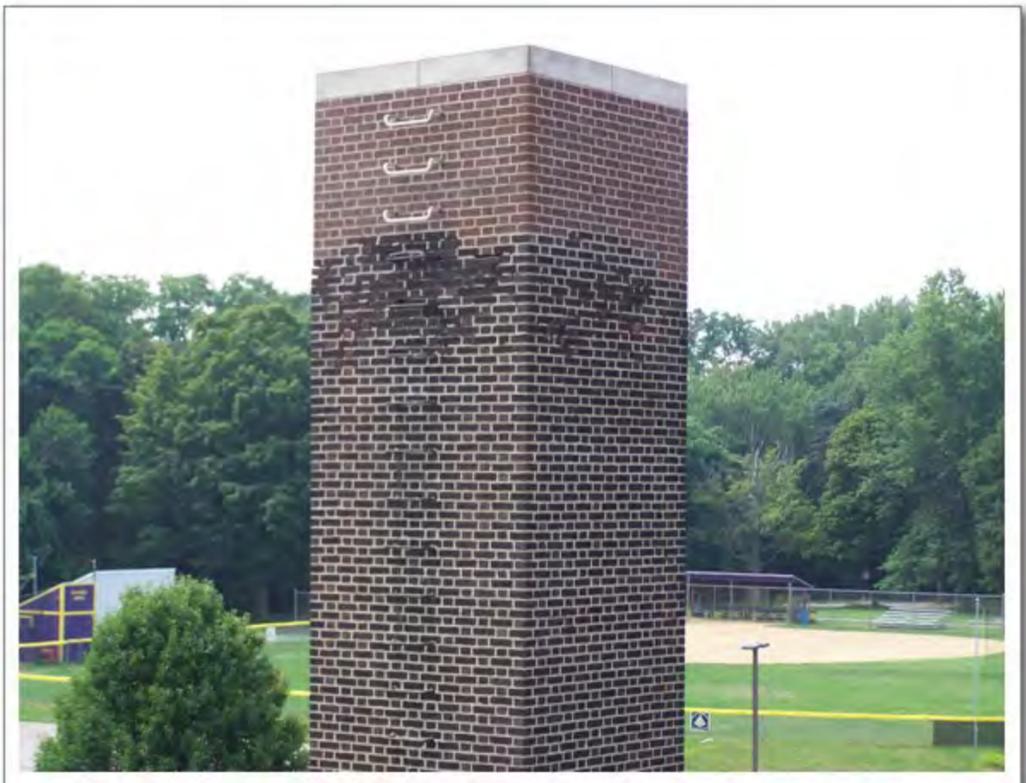
Harding 100\_2345 Stack brick mortar

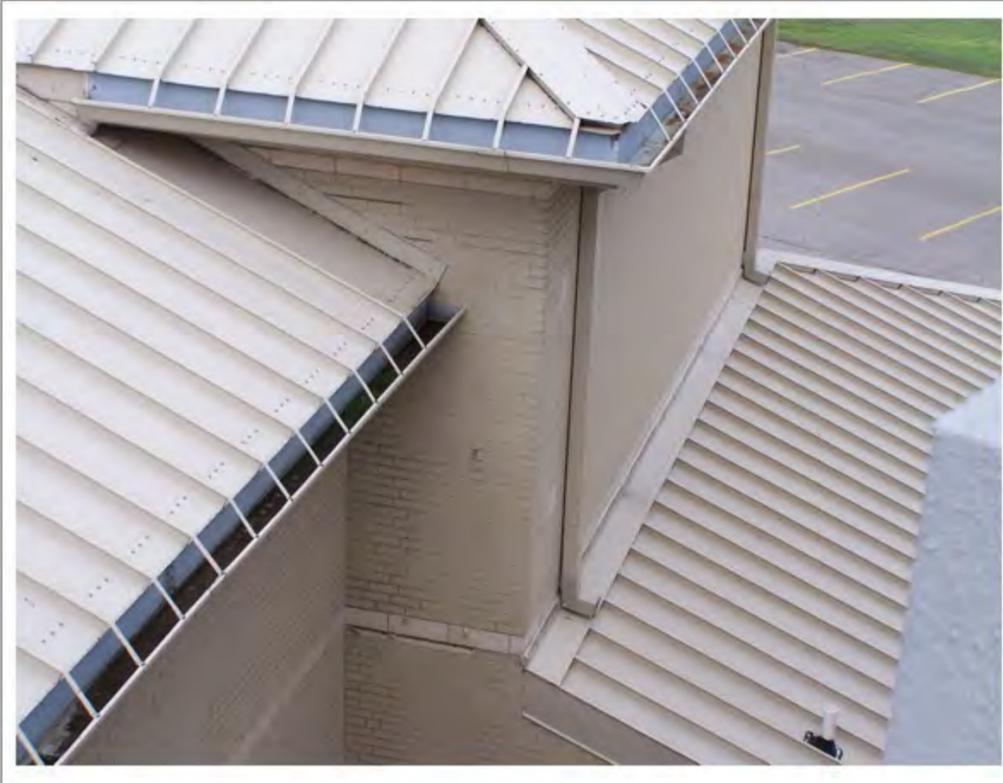
Jefferson 100\_1949 Brick and mortar

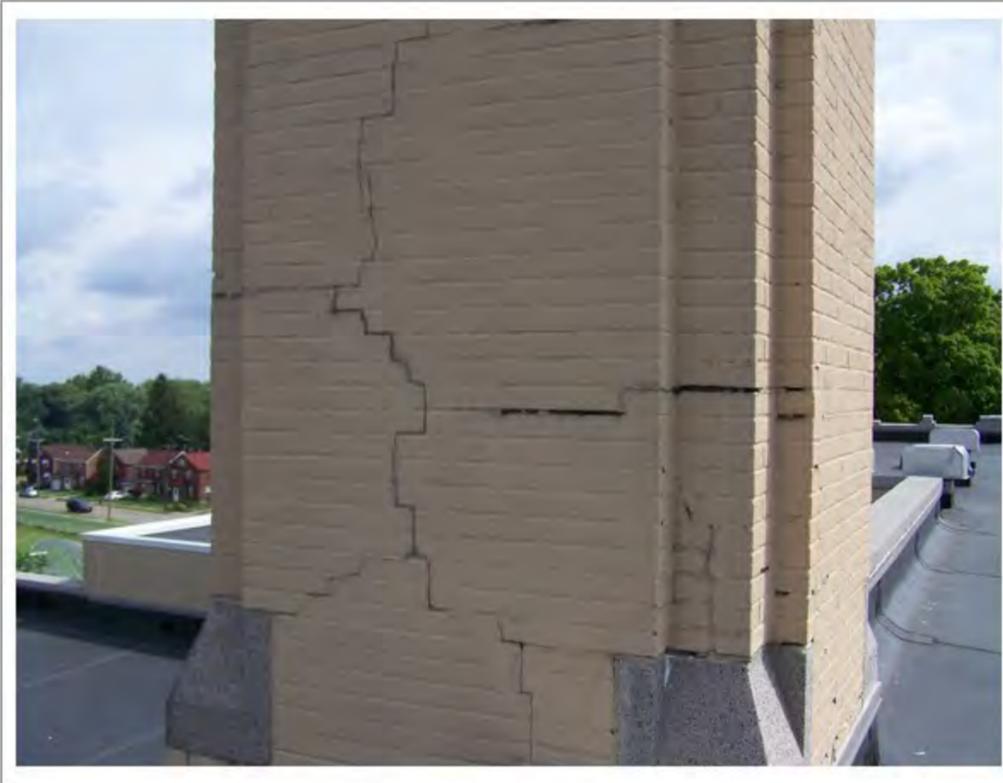
Jefferson 100\_1970 Stack brick

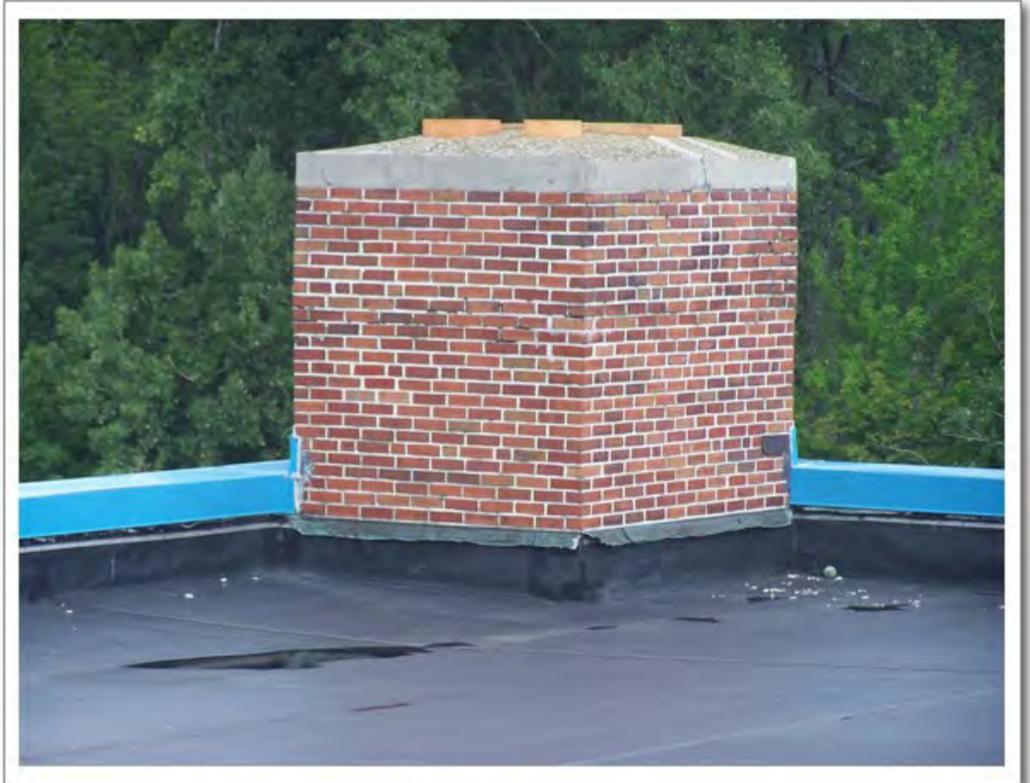
JoAnna Connell 101\_6770 Brick stack

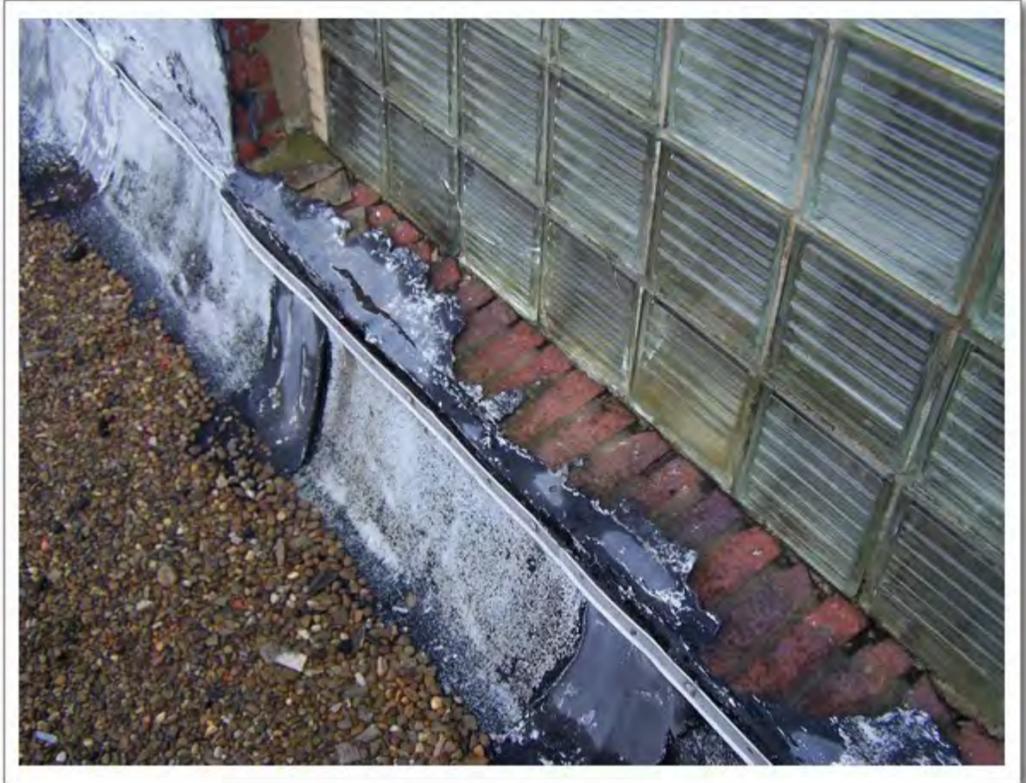
- f. Existing parapet walls at NWCA over promenade are in poor condition. The School District shall remove section over north east promenade stair wall where it is leaning over egress doors.

NWPACA 101\_6997 Parapet

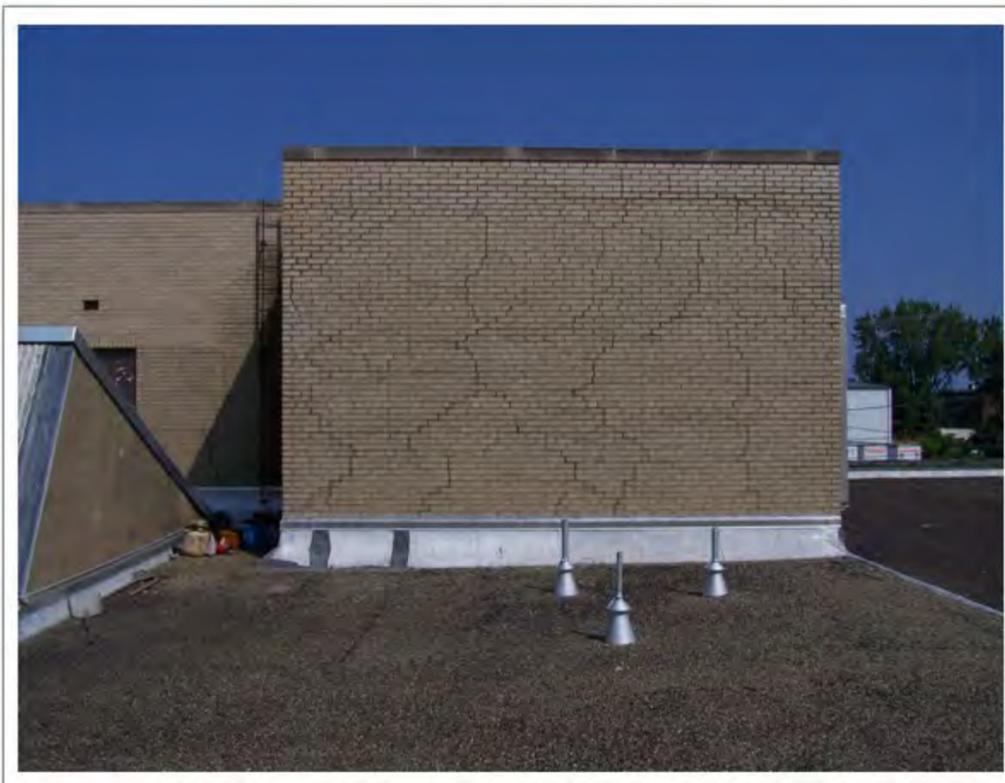
Service Cener 101\_6394 Stack

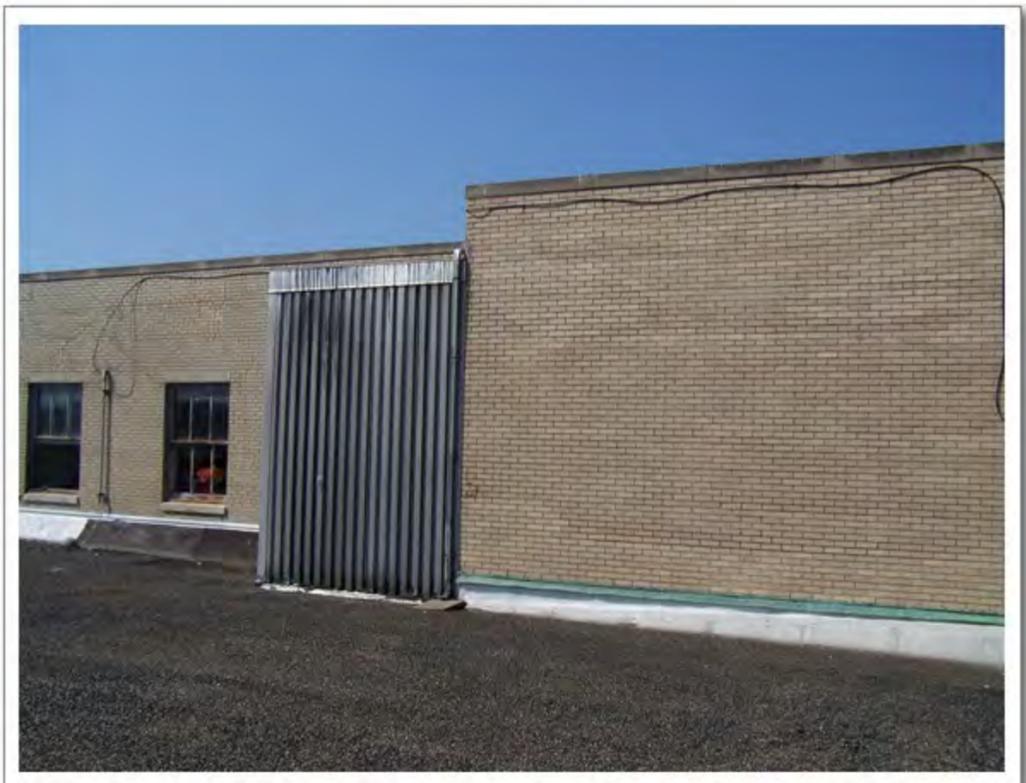
Service Center 100\_1877 Brick

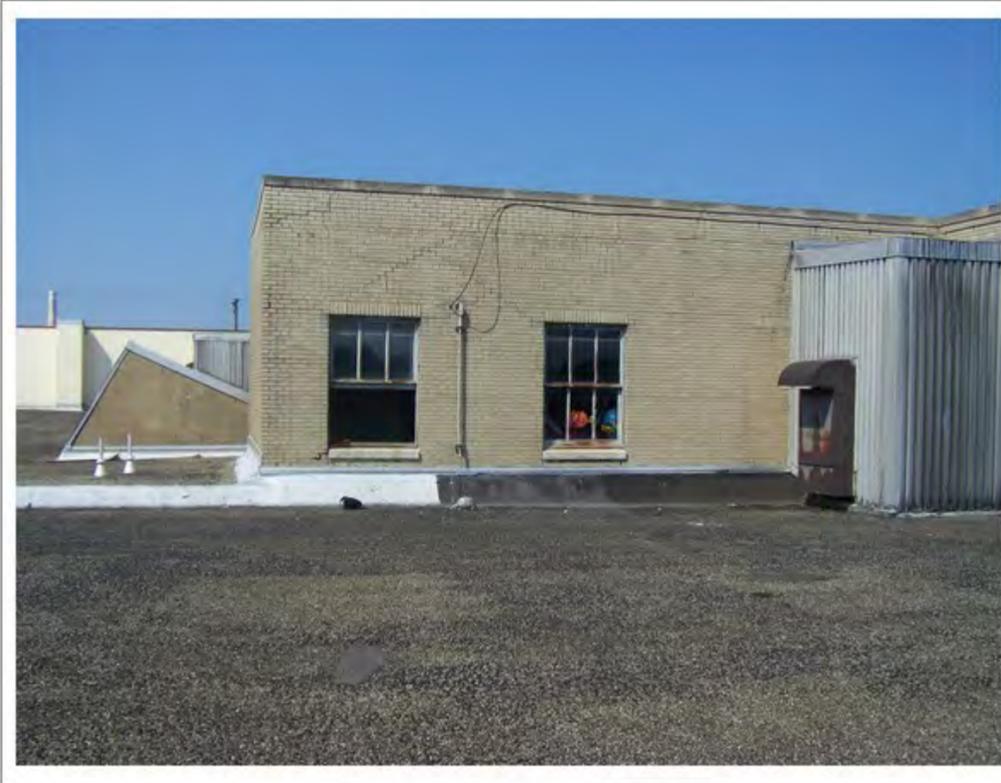
Service Center 100\_1878 Brick

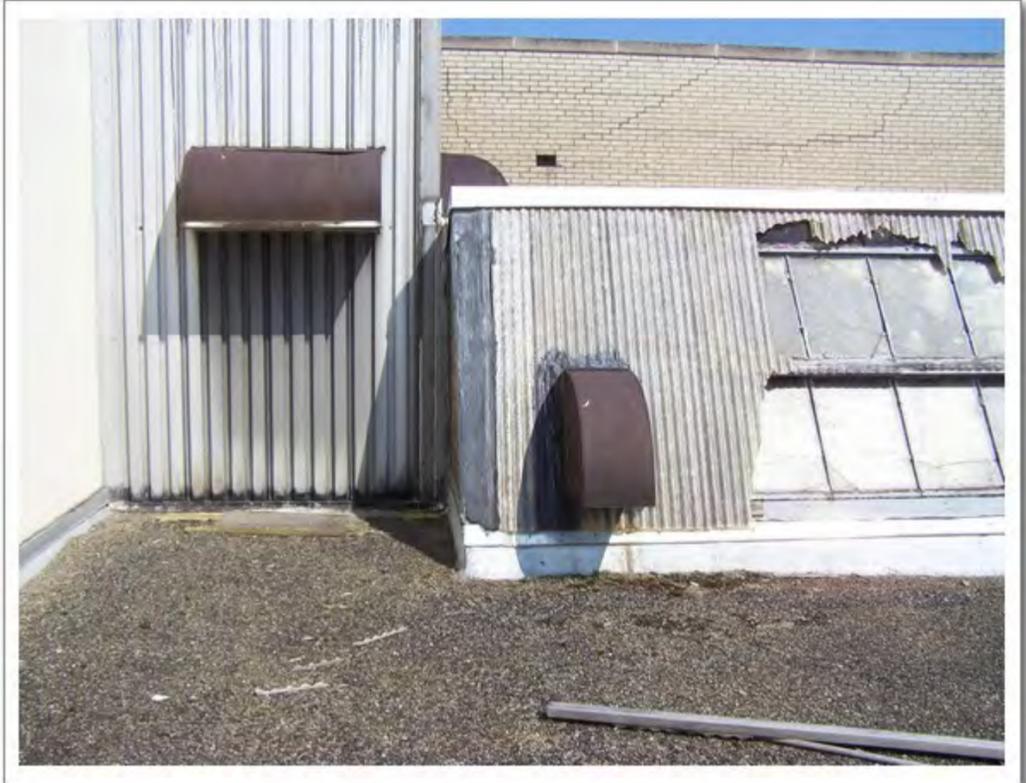
Service Center 101\_6380 Brick

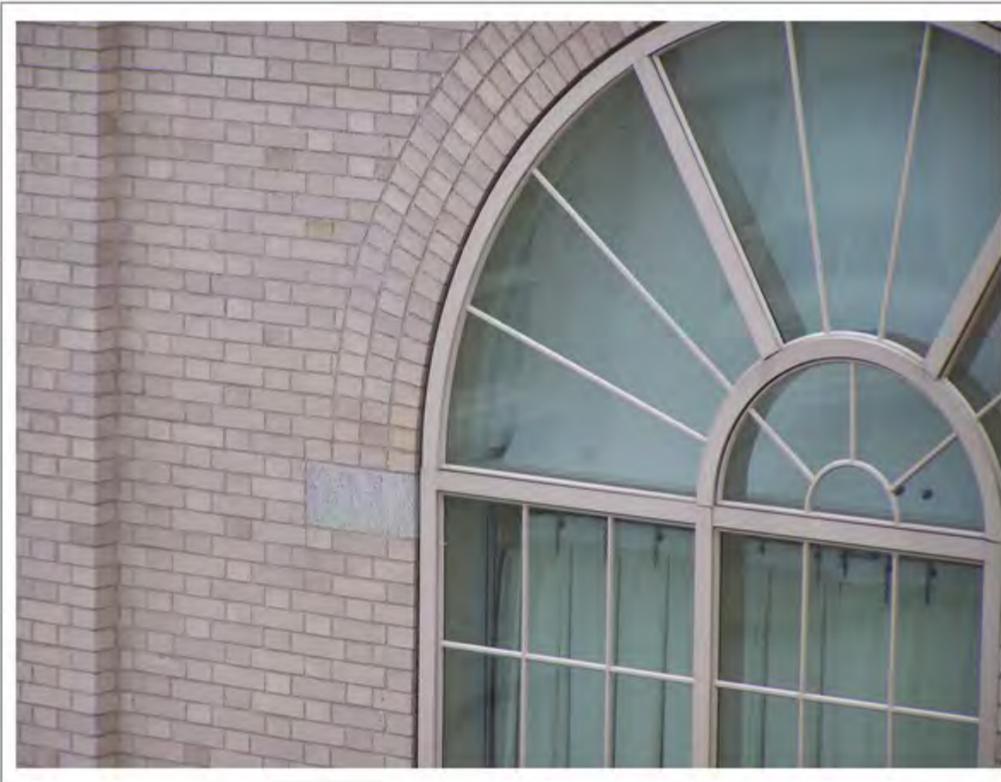
Service Center 101\_6402 Brick
